Article

Investigating the Impact of Washing Cycles on Silver-Plated Textile Electrodes: A Complete Study

Valentin Gaubert ^{1,2,3,4,5,*}, Hayriye Gidik ^{1,3}, Nicolas Bodart ⁵ and Vladan Koncar ^{1,2,4}

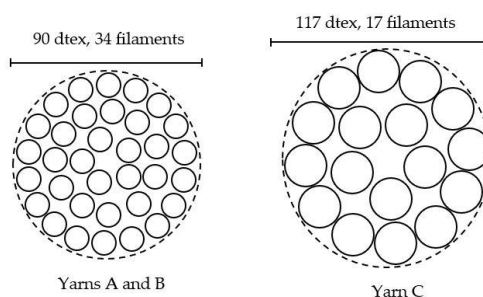
Figure 1. Yarns' structures.

Silver-plated nylon yarns were purchased from three different suppliers. They will be referred to as Yarns A, B and C. Yarns A and B have a similar structure: 90dtex/34 filaments whereas Yarn C is thicker (117dtex) and made with only 17 filaments (Figure 1). Concerning the precise nature of the yarns, no details were given by the suppliers about the core nylon or the silver used for the plating. In addition, the metalizing process, which may impact the withstanding of the silver layer, was kept secret. Double jersey fabrics (back side in cotton) were produced with each yarn on an industrial circular knitting machine (CMO4A, Orizio). Figure 2 shows the diagrammatic representation of the knitting structure of the fabrics. Then, samples of $60 \times 50 \text{ cm}^2$ and $5 \times 36 \text{ cm}^2$ were cut off from each fabric in order to be washed. Those samples were then redivided during the washing process into two lots of smaller electrodes (30 electrodes of $10 \times 10 \text{ cm}^2$ and 12 electrodes of $5 \times 3 \text{ cm}^2$) hence the chosen surface.

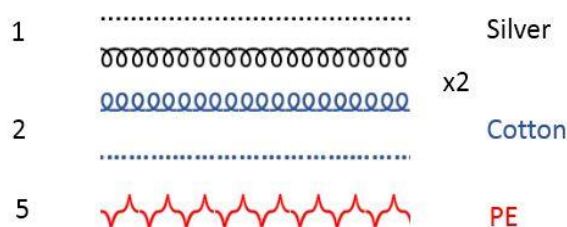
Figure 2. Diagrammatic representation of the fabric.

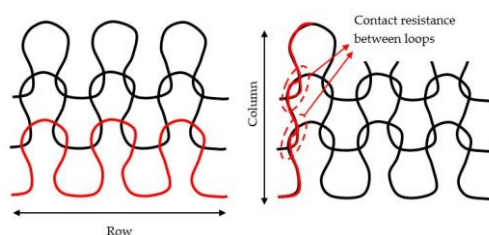
Figure 4. Current path through rows and columns.

A four-point probe system from Ossila was used for measuring the sheet resistance of the samples. This measurement uses four probes arrayed in a line, with equal spacing between each probe. A current is passed between the outer two probes, causing a reduction in voltage between the inner two probes, from which the sheet resistance can be calculated. As the samples are knitted fabric, the electric conductivity is not isotropic. Indeed, on rows, the current flow through a yarn but on columns it flows from loop to loop, creating a small contact resistance (Figure 4) as the contact between the filaments in the loop is not perfect. This resistance was quantified inferior to 1 Ω /loop by measuring linear resistance on different columns of the different samples. That is why, on each sample, measurements were done on rows and columns, then the mean was taken. For each sample, the sheet resistance was taken on three random locations in each row and three in columns to lower the standard deviation.

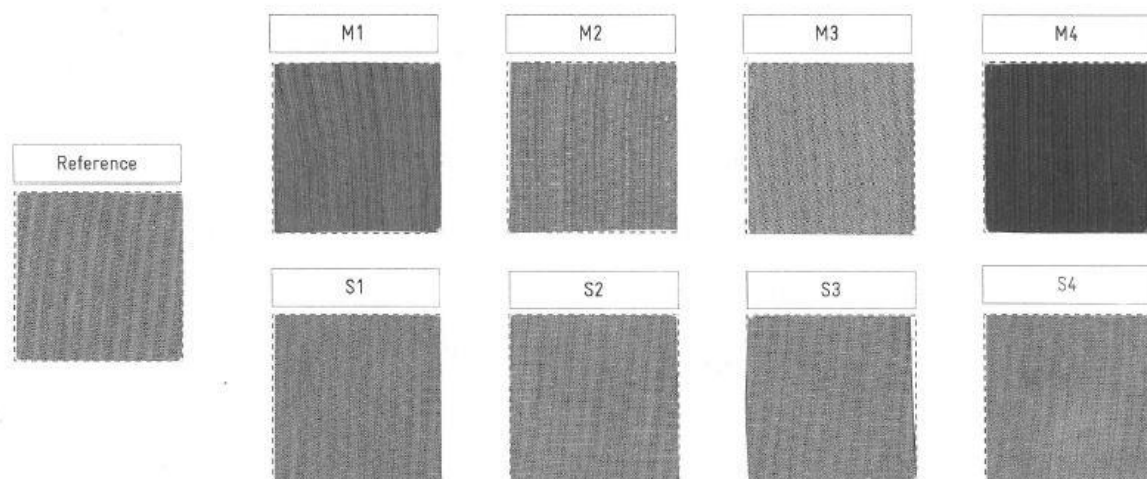
Figure 5. Aspects of 30-times-washed-electrode of each lot for Yarn A.

Regarding the visual aspect of the 30-times-washed electrodes (Yarn A) from the different lots, shown in Figure 5, the electrode from M4 has significantly darkened compared to the reference one and the others. All the electrodes from Lot S look similar to the reference one, as well as the M3 electrode.

However, M1 appears also clearly darker and M2 slightly darker than the reference. Those visual differences were further quantified by a spectrophotometer throughout the 30 washing cycles. Resulting graphs for the three yarns studied are given Figures 6 and 7.

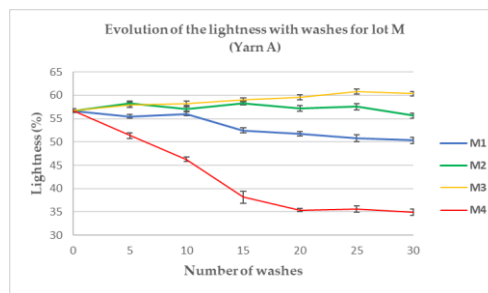
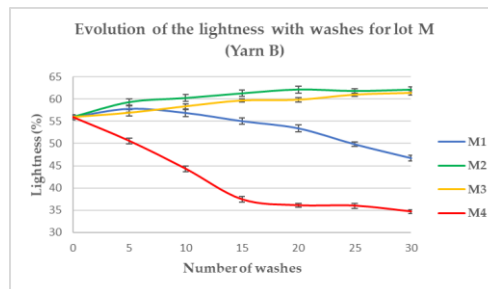
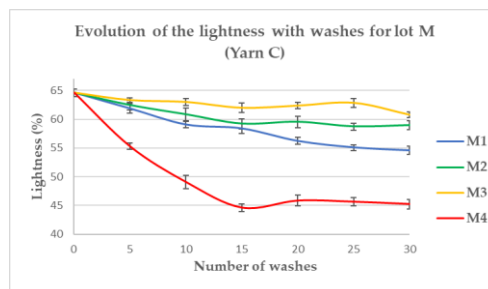
Figure 7. Evolution of the lightness with washes from Lot M, Yarns A (a), B (b) and C (c).

Although a decrease in lightness (Figures 6 and 7 and Table 1) and conductivity (Table 5) can be observed for Sublots S1 and S4 like for M1 and M4, the proportions have nothing in common. Indeed, the decline is barely significant apart from Yarn C, whose lightness dropped by 6.7% in S1 and sheet resistance was multiplied by almost four in S4. These results of the S-X sublots confirm the XPS analysis that the observed decrease in lightness and conductivity are not related only to the oxidation of the silver, turning into silver chloride but more probably to the possible removal of the silver layer from the core nylon yarn. This removal is clearly evidenced by the scanning electron microscope observations shown in Figure 9.

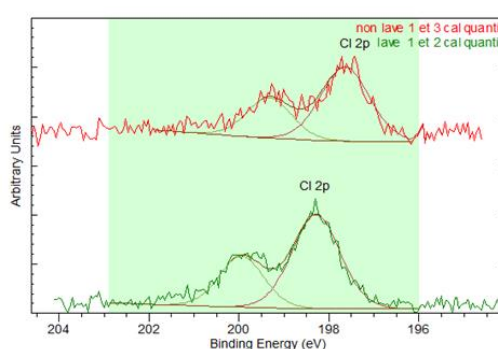
Figure 8. XPS spectrum of the chlorine detected on the electrode M1 yarn A.

surface, turning into silver oxides. However, X-ray spectroscopy analysis, presented in Figure 8 and Tables 3 and 4, shows that it is only partially the case. Indeed, the chlorine detected at the surface of the observed 30-times-washed electrode (Yarn A, M1) seems to be a metal chloride (Figure 8), regarding its binding energy around 198.5 eV [19]. It indicates that some silver chloride (AgCl) was formed. Indeed, according to Table 3, there is four times more chlorine after 30 washes with a powder detergent than on the reference sample (which has in fact been washed once after the knitting process, hence the presence of chlorine). This formation of silver chloride could have accounted for the previous findings. Looking closer at the values in Table 3, these silver oxides represent only 2.2%, which is meaningless compared to the decrease of the pure silver itself. Indeed, at the surface of the electrode, only half of the silver quantity still remains. This wiping out of silver is even more highlighted by Table 4 which presents the surface composition of the 30-times-washed-electrode from M4. Only 1.1% of silver remains at the surface of the analyzed zone of the electrode M4, Yarn A, which represents 7% of the silver quantity on the reference.

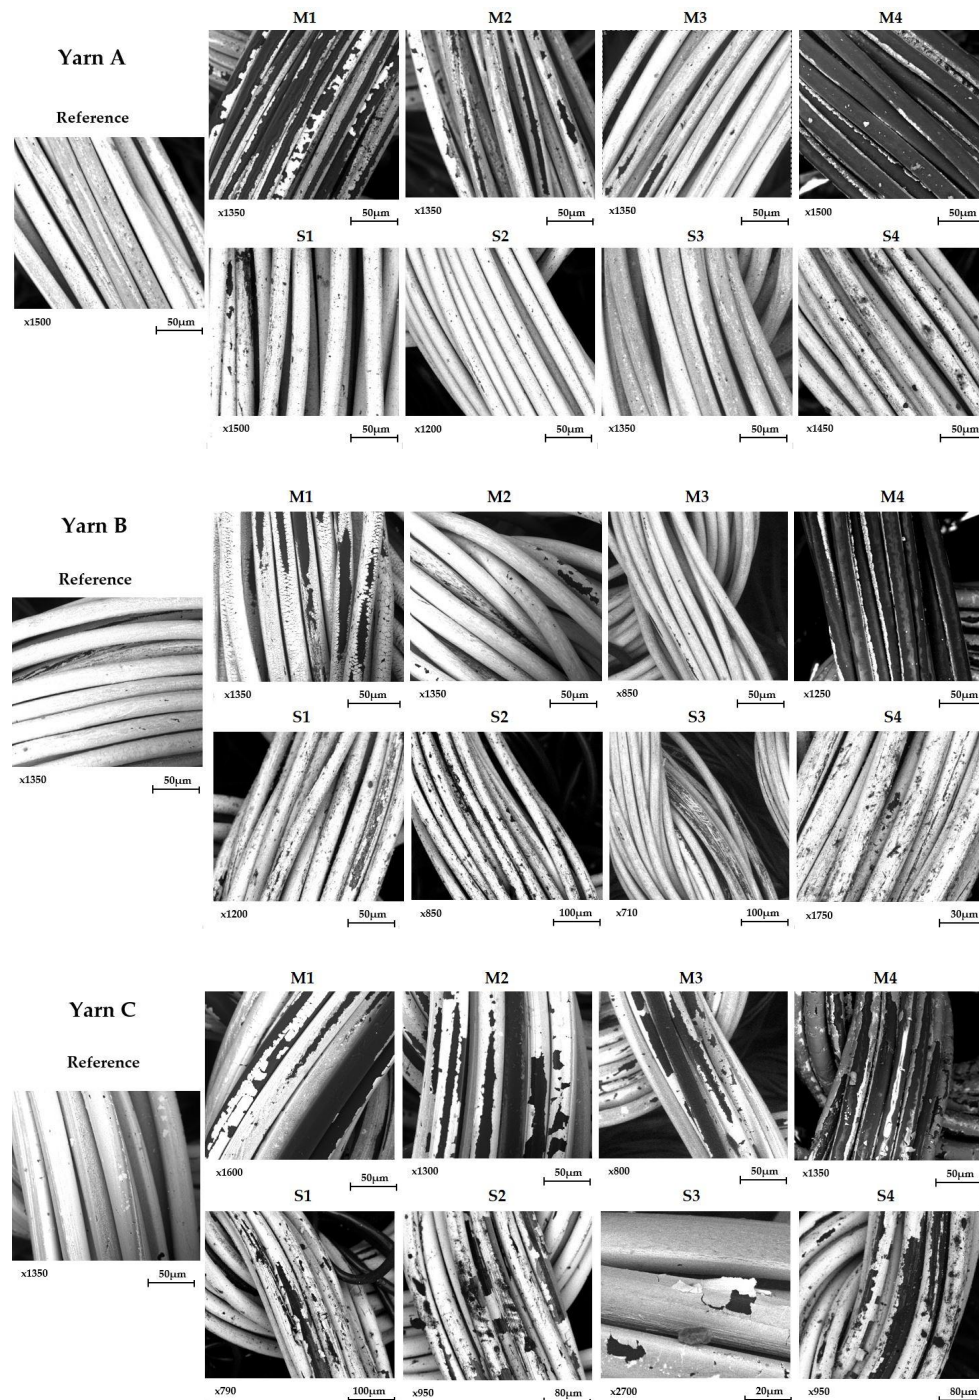
Figure 9. SEM observations of the electrodes made with Yarn A (top), Yarn B (middle) and Yarn C (bottom) for all the sublots.

These images explain well all the previous findings. Indeed, the loss of lightness and conductivity can be clearly related to the depletion, even the wipeout of the silver layer. Focusing on M4, there are no longer silver on the outside of Yarns A and B, hence they cannot be conductive anymore. Yarn C did not lose all its silver, explaining why its lightness decreases slighter than Yarns A and B, but still way too much to have a resistance lower than 10 M Ω . To account for the lightness that seemed to tend towards a lower limit after 20 washes, it was found on SEM images that all the exposed silver has already been removed after 20 washes. The measured lightness after 20 washes is one of the core nylons. The damaging of the silver layer also accounts for the results of M1, where the darkening and loss in conductivity were smaller. Indeed, the silver layer is seriously damaged. Some silver pieces still remain but they are isolated from one to another so the electrons cannot move. Such discontinuities in the silver layer are typically the scourge of Yarn B. For Sublot M1 where silver still remains, multiple small cracks in the conductive layer impeach the current to flow. Although a silver layer of samples from lot M2 presents some scratches, there is still continuity in the layer, making it able to keep a resistance lower than 10 M Ω even after 30 washes. Liquid detergents do also have an impact on the silver layer but in reasonable proportions. It is interesting to note that even washing 30 times with tap water in a washing machine damages the yarn (see M3 in Figure 9 for all the yarn). This is due to the rubbing against the drum of the washing machine and nothing can be done apart from reducing the spinning speed. That is why the delicate cycle has to be selected in order to reduce the number and intensity of the frictions against the drum. On the one hand, mechanical constraints of the washing machine do have an impact on the silver layer, to a further extent on the electrodes' conductivity and performance. However, taken alone, this impact is very weak regarding the results of samples from Sublot M3. On the other hand, the chemical species contained in detergents alone have also a low impact as it can be seen on all the S-X images and results shown in previous tables. Even though, yarns from S4 and S1 present some damages their conductivity is still acceptable. However, when combined together, the simultaneous impact of chemical and mechanical actions can be devastating as seen on Sublot M4. Their cumulative effect is way superior to the sum of the impact taken separately. Eventually, even though oxidation of the silver layer is not directly observable at the surface of machine-washed electrodes, it does not mean that it did not occur. It means that oxidation has made oxidized elements more amorphous so more vulnerable to the mechanical constraints of the machine. It should be noted that contrary to Yarns A and B, which are barely not affected by tap water, the silver layer from Yarn C tends to delaminate, even in tap water, as shown in Figure 9. This phenomenon is too scarce to have a direct impact on the lightness and conductivity of the S3 electrode from Yarn C. Hence, it is not clearly noticeable in the S3 results presented by Tables 1 and 5. Nonetheless, it can explain the overall poorer results of Yarn C compared to Yarns A and B in this study.

As these SEM images only analyze and show few mm² of an electrode, which is a hundred times larger, global conclusions cannot be drawn directly from these. That is why, to confirm what was visually observed qualitatively, a quantitative study was led. It consisted of quantifying the silver layer on each yarn by thermogravimetric analysis (TGA). As the degradation of nylon starts at around 330 °C and silver is not degraded till 900 °C, the weighed residue is only composed of pure silver at this temperature. It turned out that measurements have a high standard deviation. It can be explained because, on the one hand, the plating of silver is not strictly identical from one bobbin to another, and on the other hand, mechanical constraints from the washing drum are not equally applied on the fabric during the washing cycles. That is why a deeper analysis was done on Yarn A for investigating the impact of the bleaching agents on the silver content. Five successive measurements were done for each of the searched silver content (before washing and after being machine-washed 30 times). A comparison between yarns was also done, by measuring the silver content of each yarn for Sublots M-X. For Yarns B and C, only two measurements were done for each sample.

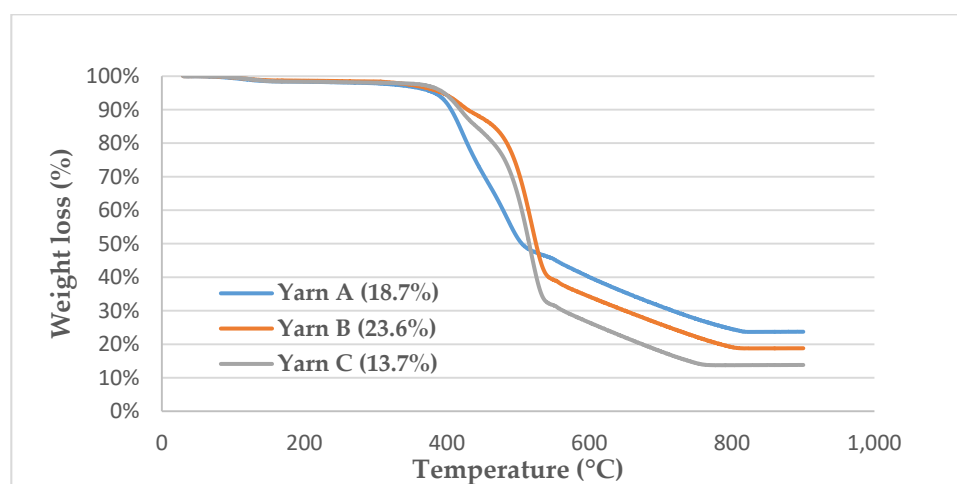
Figure 10. TGA curves of the reference Yarns A, B and C.

Firstly, the silver content of the reference electrode (before washing) from each yarn was measured in order to compare them (Figure 10). It turns out that Yarn B has a higher silver content and even contains almost twice more silver than Yarn C. It is interesting and reassuring to note that these three

yarns were bought at three different prices, which in fact, respectively, varies according to their silver content. It would have also been tempting to link the silver content to the thickness of the silver layer, but it is not totally true. Indeed, a direct comparison cannot be drawn between Yarn C and the others as it is not perfectly similar in its construction. Whereas Yarns A and B have the same thickness and number of filaments, Yarn C is thicker but made with twice fewer filaments. As a result, the thickness of the silver layer cannot be compared directly with the measured silver content. It has neither been possible on SEM cross-section observations as the layer is so thin that the mechanical action of cutting the yarn distorted it. Nonetheless the withstanding to washes of the respective layers can be compared one to another by measuring the loss in silver content. A relatively high standard deviation was found for these measurements. Two phenomena can account for that. On the one hand, a small deviation is produced by the metalizing process itself. On the other hand, the fabric is made from different yarns coming from different bobbins, so they have overcome similar but not strictly identical mechanical constraints during the spooling, knitting and manual unknitting. The sum of those micro-constraints has a meaningful impact on the final silver content. Therefore, silver losses for Yarns A and B of Lot S cannot be distinguished from the measurement uncertainty that is why this quantification has only been done for Sublots M-X. Table 6 presents the different losses according to the washing conditions. As already highlighted by the previous results, the silver layer on Yarn C is globally less resistant than the other two yarns. The most striking difference is for the subplot washed only in tap water (M3) where Yarn C lost almost 18% of its silver content comparing to around 3% for Yarn A and less than 1% for Yarn B. The delamination of the silver layer occurs when the yarn is just soaked into water, shown in Figure 9. The image S3 for Yarn C from Figure 9 shows clearly such a result. It is also interesting to note that Yarn B is seriously stronger than Yarn A. As they have the same structure (thickness and number of filaments) their silver content reflects the thickness of their silver layer. According to the measurement of their respective reference sample, the silver layer of Yarn B is thicker than the one of Yarn A. Hence, the results of Table 6 indicate that the thicker the layer, the stronger. In other words, the thinner the layer, the more vulnerable to the constraints, which seems to intuitively make sense.

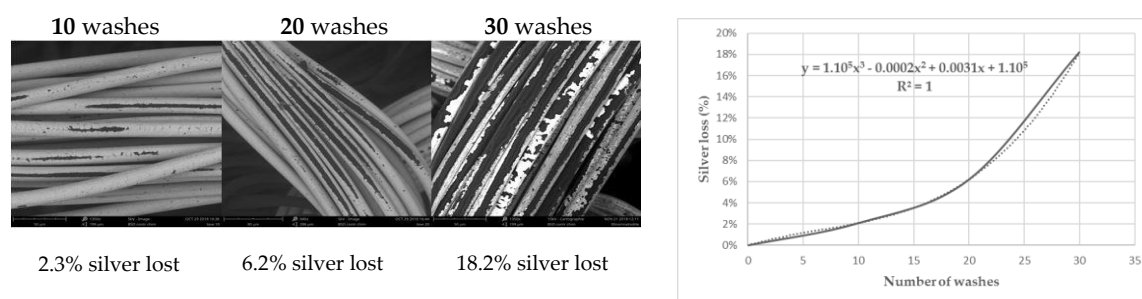
Figure 11. Evolution of the silver depletion with the washes, (left): SEM observations of the samples washed 10,20 and 30 times; (right): graph showing the silver loss according to the number of washes.

However, as evidenced by Figure 11, showing the silver depletion with the number of washes, the depletion is not linear but rather polynomial. It goes with the previous findings that the thinner the layer the more vulnerable. Indeed, each washing cycle tends to diminish the silver layer making this layer even more vulnerable for the washing cycles to come.
